Project: Dallesport Industrial Park, Condition Survey of Water Tank
WJE No. 2002.1428

Re: Condition Survey for Welded, Plate Steel Water Tank
Dallesport Industrial Park
WJE No. 2002.1428

In accordance with our proposal dated 8 April 2002, the welded plate-steel water tank located at the Dallesport Industrial Park in Dallesport, Washington was inspected by Wiss, Janney, Elstner Associates Inc. (WJE). The 13 April 2002 inspection addressed all above grade structural elements of the tank, as well as interior and exterior surfaces of the plate steel shell.

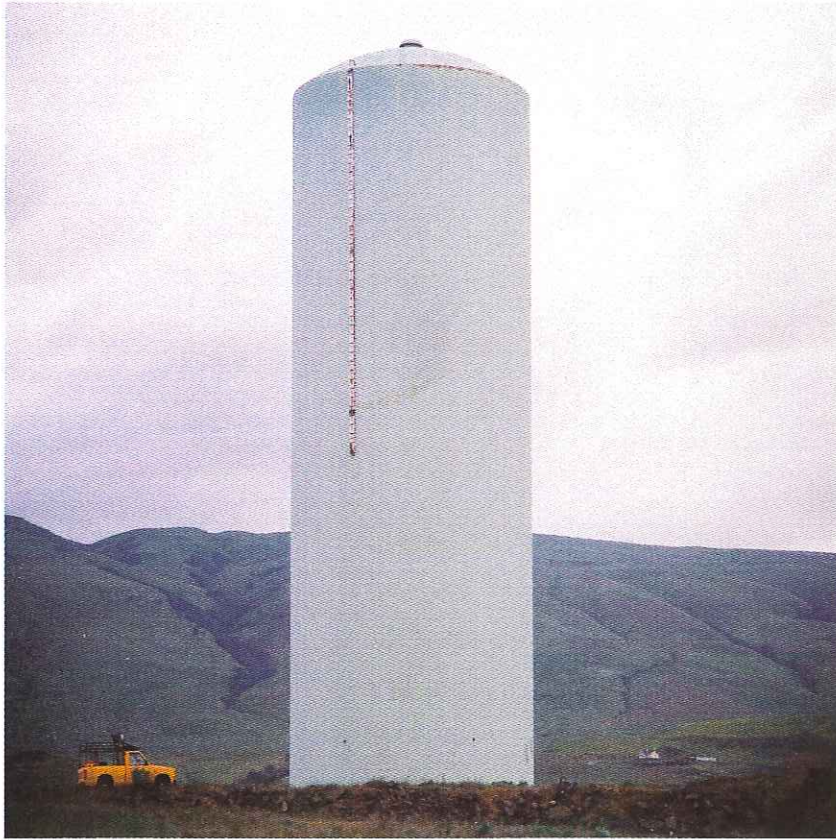
The standpipe tank shown in Figure 1 was constructed by Pittsburgh-Des Moines Steel Company in 1972. The steel plates of floor and roof assemblies were configured with lap splices and joined with fillet welds. Fabrication drawings provided to WJE for reference indicated complete penetration butt joints for segments of the plate steel tank walls. Anchor straps that were embedded into the concrete foundation were joined with fillet welds to the lower course of shell plates. Protective coatings were applied to both interior and exterior surfaces of the tank.

Figure 1. Dallesport Industrial Park standpipe water tank viewed from southwest

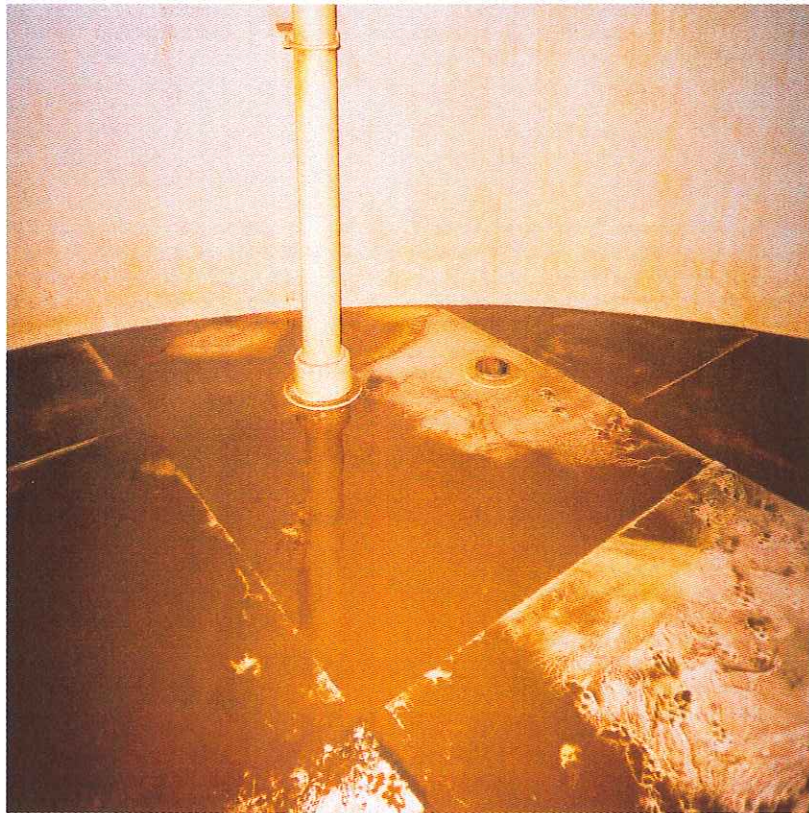
Floor plates were assembled as shown in fabrication drawings, and joined with fillet welded lap-splices, as may be seen in Figure 2. Random locations of each plate section were selected for ultrasonic thickness testing, and a surrounding area of about one square foot was surveyed for corrosion pitting. No evidence of significant underside corrosion damage was detected within the test areas, and no evidence of corrosion

damage was observed on the upper surface or floor of the tank. Nominal measured plate thickness exceeded 5/16 inch. Table 1 contains a summary of the ultrasonic thickness measurements.

Figure 2. A muddy residue left after removal of the water partially obscured portions of the steel floor plates:

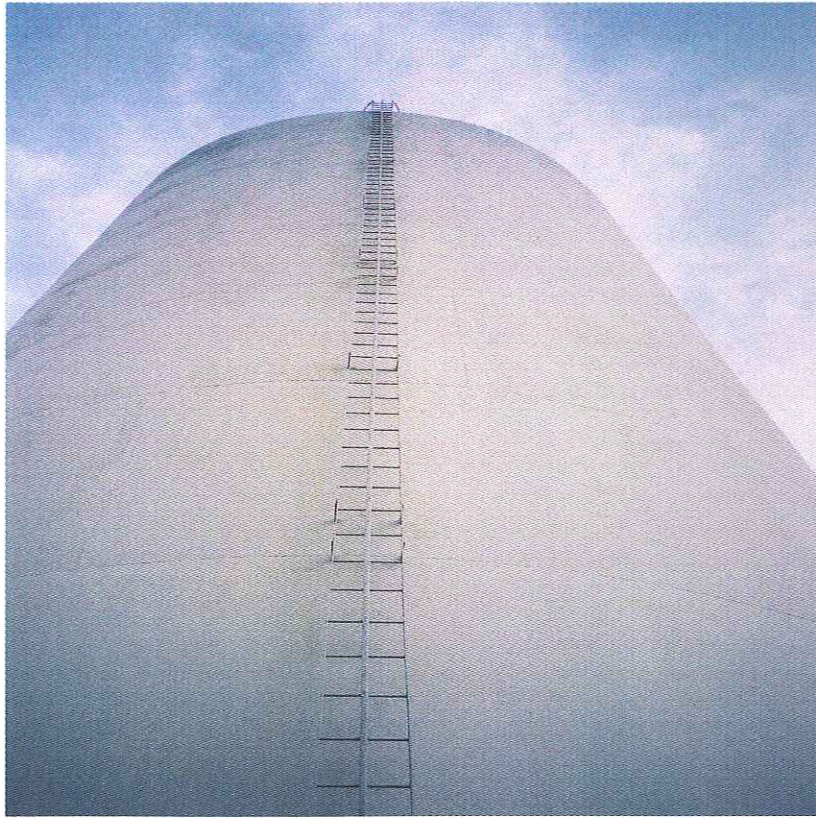
Wall plate for the tank was made up of nine girth sections with butt joint welds between successive courses, and staggered vertical butt joint welds between girth segments. Ultrasonic thickness measurements were made for wall plates within arms reach of the roof access ladder shown in Figure 3, at approximately mid-height of each girth section. Wall plate thickness measurements are summarized in Table 2.

Figure 3. An access ladder attached to the tank extended from the 2nd girth plate level to the roof.

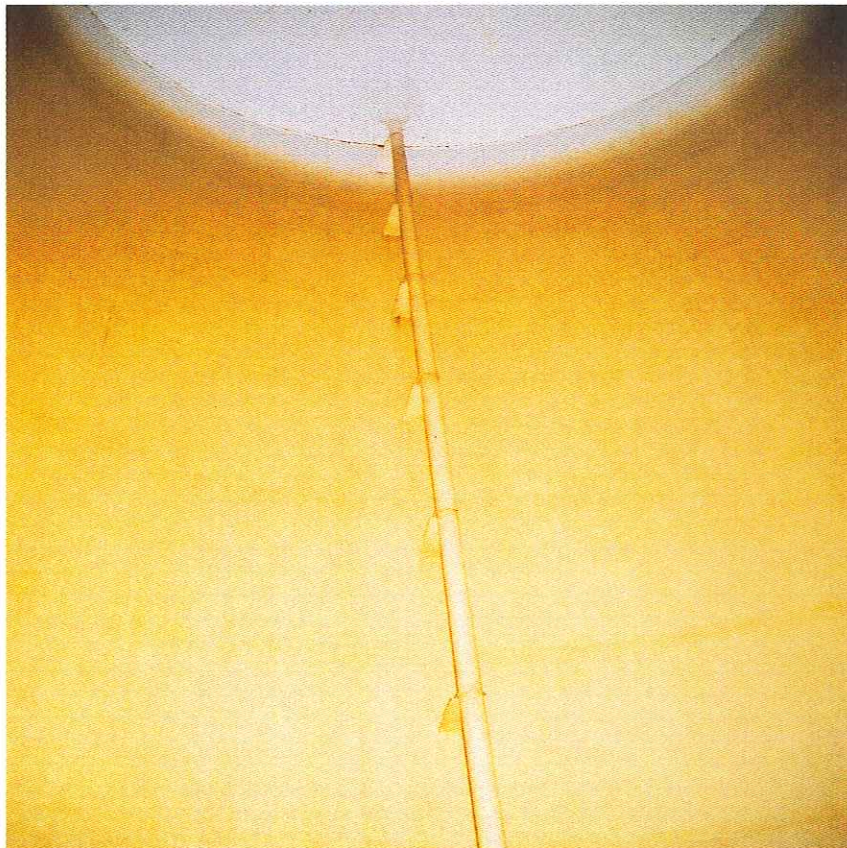
Observations of interior coatings were made from the floor of the tank. No access ladder was installed at the interior; therefore, only the lower course of plates could be accessed for close-up inspection. In general, the coating system as shown in Figure 4 appeared intact. Small diameter blisters however, mostly 1/8 to 3/4 inch in diameter, as shown in Figure 5 were observed in localized areas. A few blisters that were opened had retained water, and some corrosion product was evident. About six observed rust nodules exceeding one inch in diameter apparently occurred at locations of attachment hardware for exterior fixtures, and were not associated with failure of the coating. Lap splices in the roof of the tank were not required to be welded at the interior surface, and exhibited evidence of ongoing corrosion at and adjacent to lapped joints, as may be seen in Figure 6. Deterioration at the roof perimeter ring joint, as shown in Figure 7 may indicate the most significant potential for loss of structural integrity to the tank due to corrosion damage. The extent of damage due to corrosion pitting could not be fully determined without close-up access; there is no evidence however of extensive deterioration or of imminent impairment to the integrity of the structure.

Figure 4. The interior coating generally appeared to be intact.

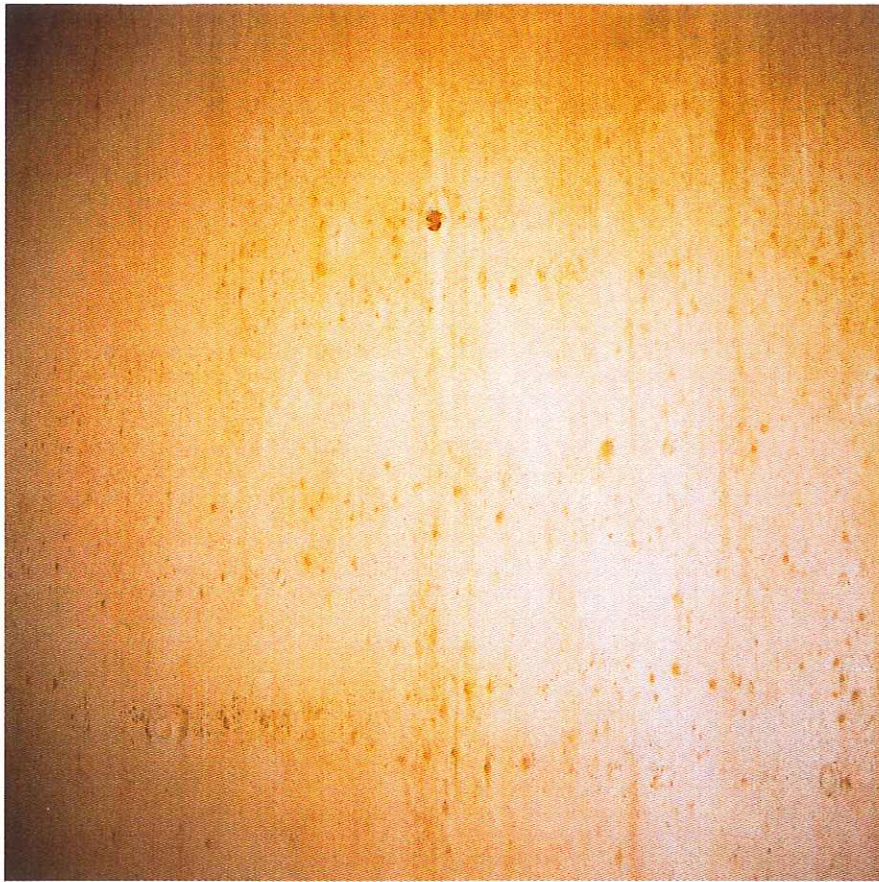
Figure 5. Blistering of the interior coatings was observed in local areas.

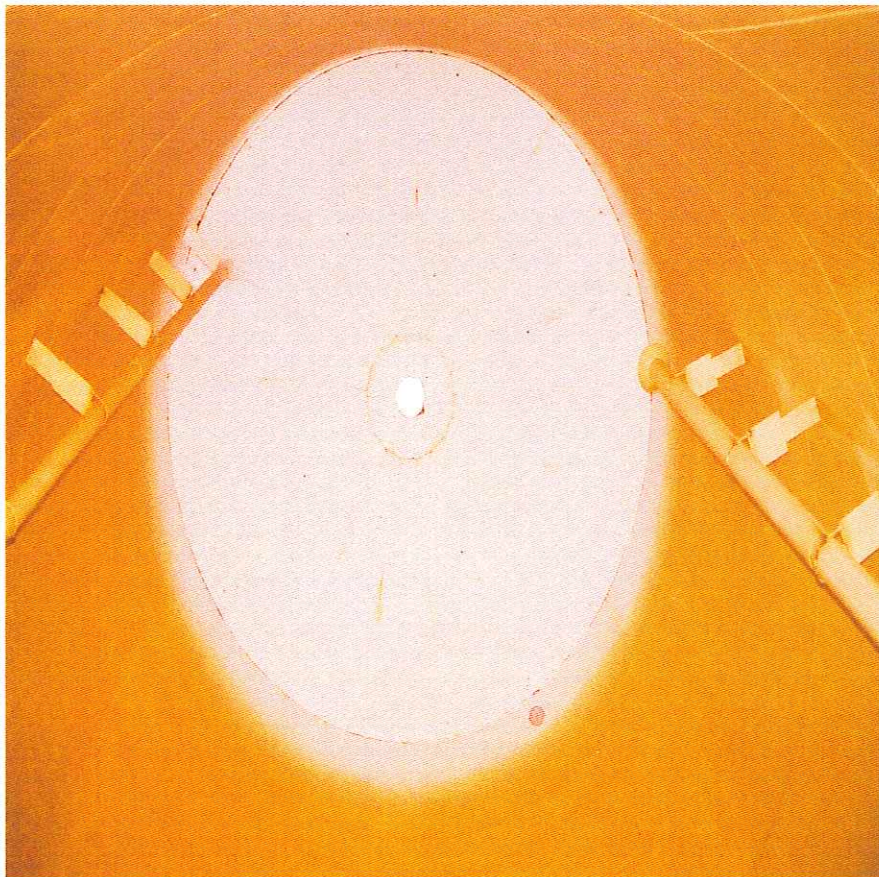
Figure 6. Corrosion staining of roof plate lap joints was observed at the interior of the tank.

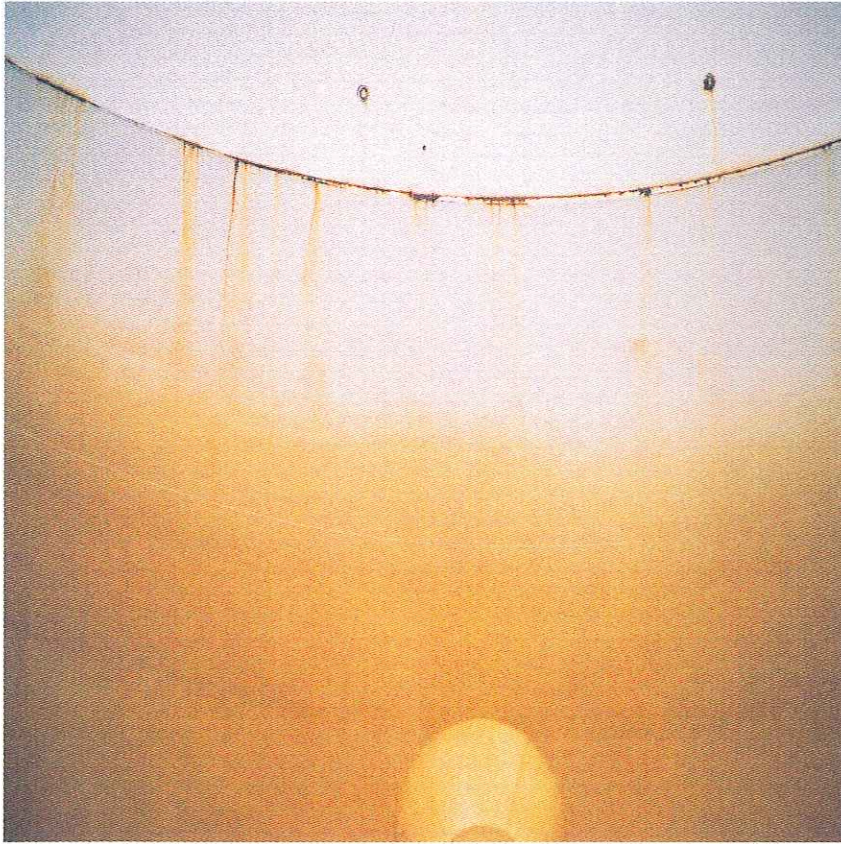
Figure 7. Corrosion deterioration at the roof perimeter ring lap joints was apparent through much of the tank circumference.

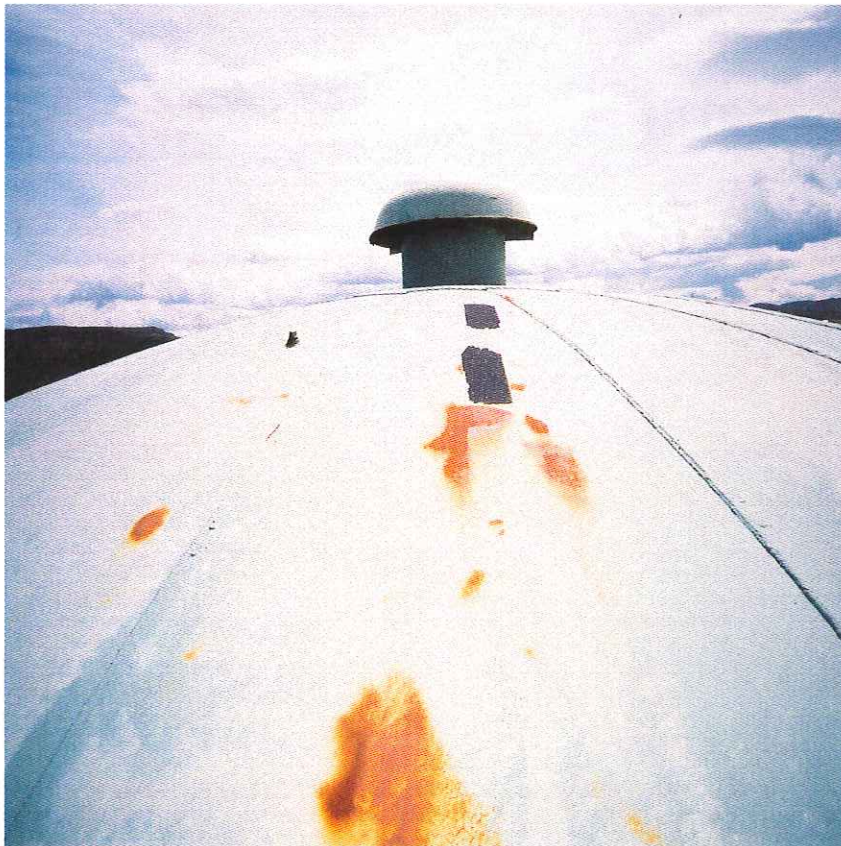
The exterior coating was observed from ground level surrounding the tank, as well as from the roof access ladder and from the rooftop. Close-up viewing supported the general observation that a coating is intact and remains well adhered, although the finish-coat of the system had eroded in some locations. Deterioration was most severe at surface areas of the roof, as shown in Figure 8. Surface corrosion of the tank shell as seen in Figure 9 was observed at several localized areas of both roof and wall plates where the remaining coating coverage appeared to have insufficient thickness. The coating was typically weathered, leaving a chalk-like residue at the surface.

Figure 8. Thinned and worn exterior coatings were most severe at areas of the exterior roof plate.

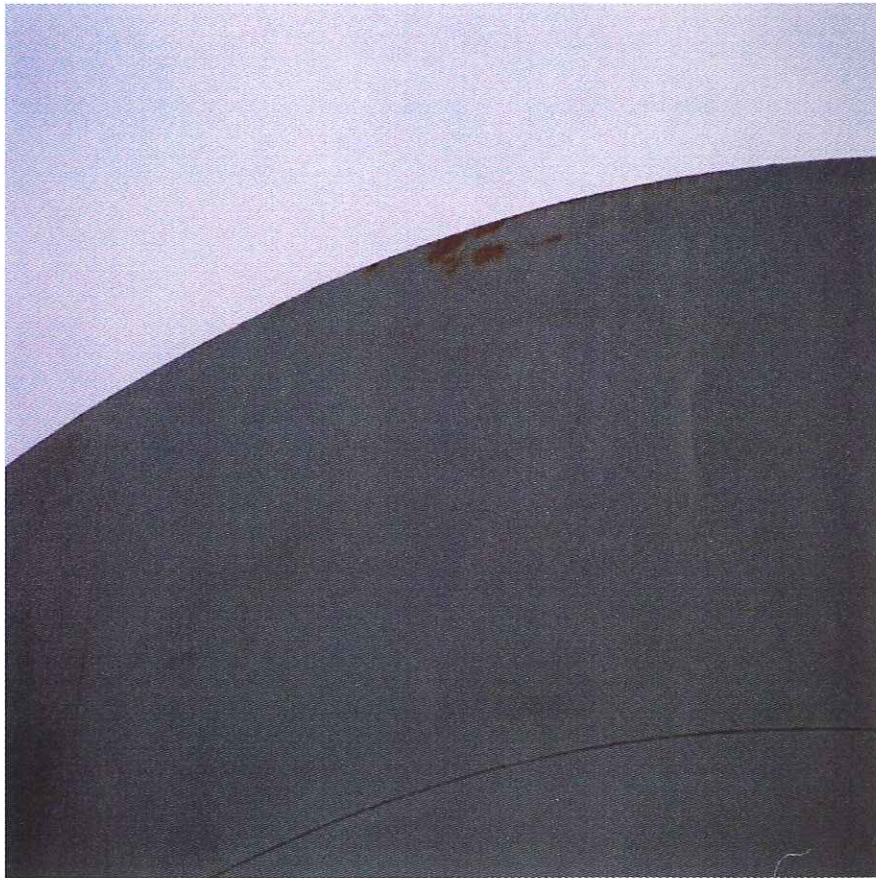
Figure 9. Thinned and worn exterior coatings observed mostly in upper wall and roof plates no longer provide protection from corrosion; however, surrounding areas were well adhered.

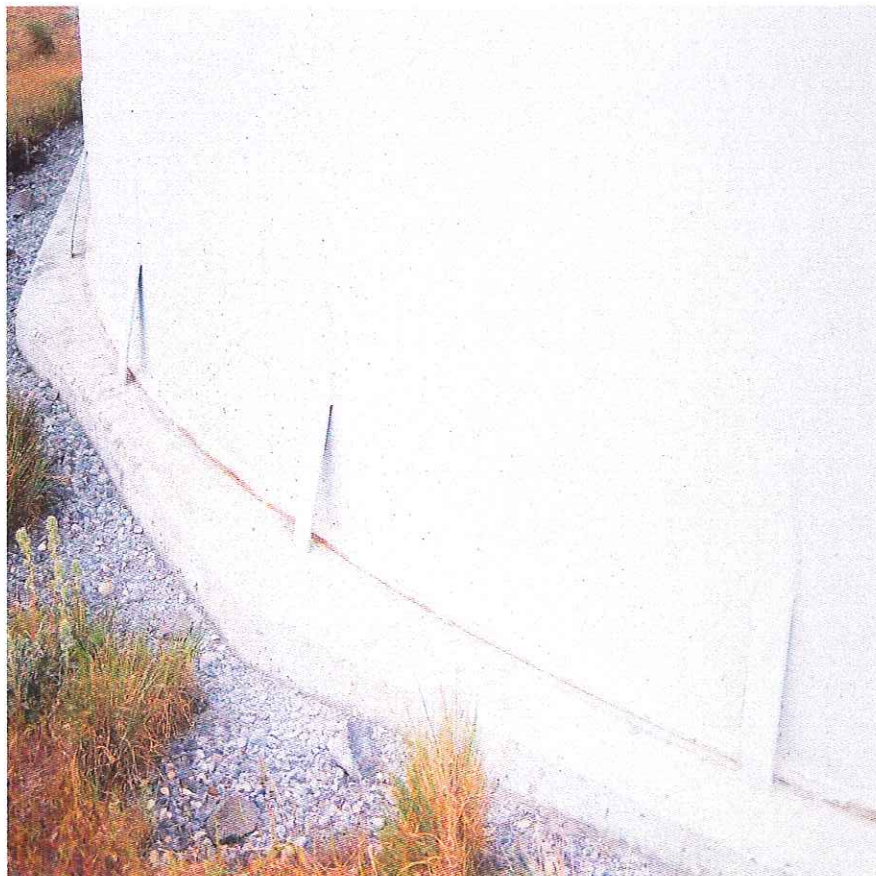
Although not within the scope of work, anchorage straps as shown in Figure 10 were observed and measured. All straps were configured as shown in fabrication drawings with a nominal width of 3 inches, and thickness of 3/8 inches. Spacing of the straps was not uniform, ranging from 46-3/4 to 61 inches. Table 4 presents the sequential on-center spacing measurements of the twenty eight straps. Straps were joined to the lower wall plates with fillet welds as specified in fabrication drawings. Based on cursory observations, approximately 40 to 60 percent of the fillet joints appeared to be in non-conformance with design specifications. Non-conformity included under sizing of deposited weld metal, and reduction in the effective throat as a result of the gap remaining at the faying surfaces of the strap and the tank wall, as shown in Figure 11. No evidence of cracking or distress was identified.

Figure 10. Straps embedded in the tank foundation were joined with fillet welds to the lower wall plates.

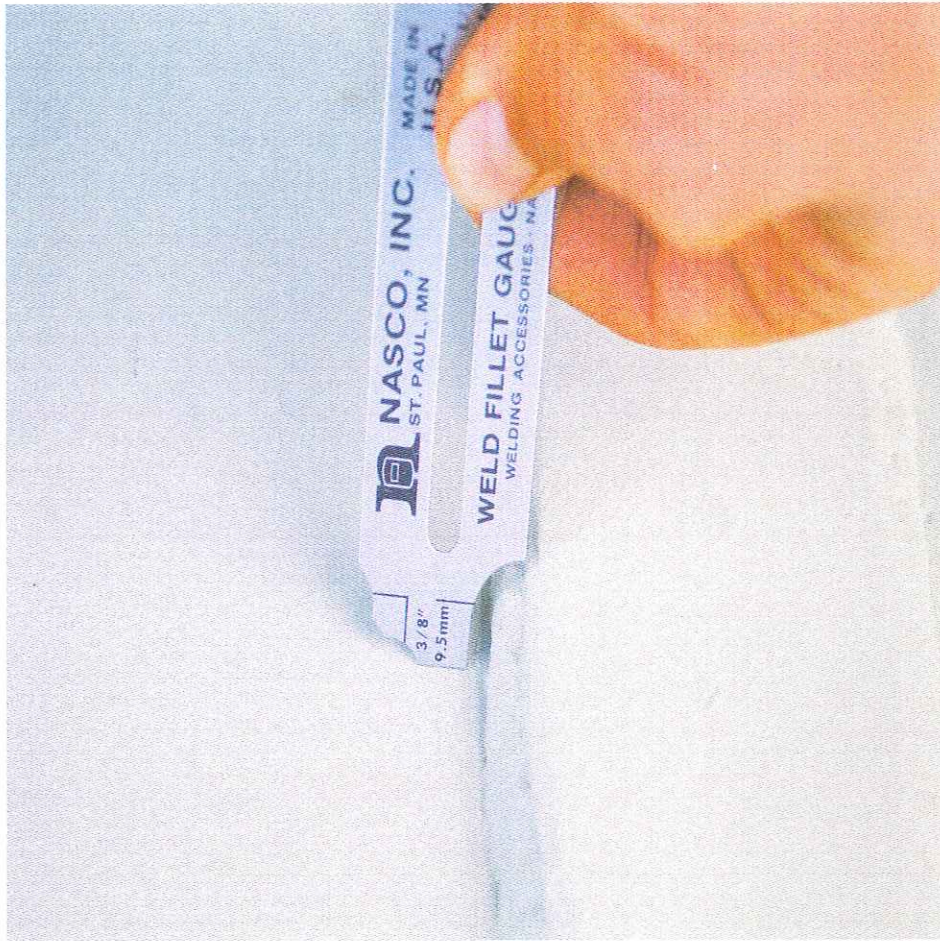
The Dallesport tank was constructed in general accordance with the fabrication drawings and is in serviceable condition. No evidence of measurable pitting from corrosion was observed visually or detected from ultrasonic tests in floor, wall, or roof plates. Interior coatings appear to be in fair condition with relatively minor blemishes. The exterior coating is intact overall, but is worn and gradually diminishing in effectiveness to resist atmospheric corrosion of the tank shell plate. Anchorage straps appear to be free of corrosion or distress, however many of the associated fillet welded joints appear to be in non-conformance with respect to the requirements of the specified design.

Figure 11. Fillet welded joints of many anchorage straps do not satisfy design requirements due to the excessive gap between adjoining surfaces, undersizing, and poor profiles.
