**REPORT
PRELIMINARY SITE ASSESSMENT
103 ACRE SITE
BINGEN, WASHINGTON**

**TEUTSCH PARTNERS
Job No. 21172-001-005
September 7, 1990**

**DAMES & MOORE**

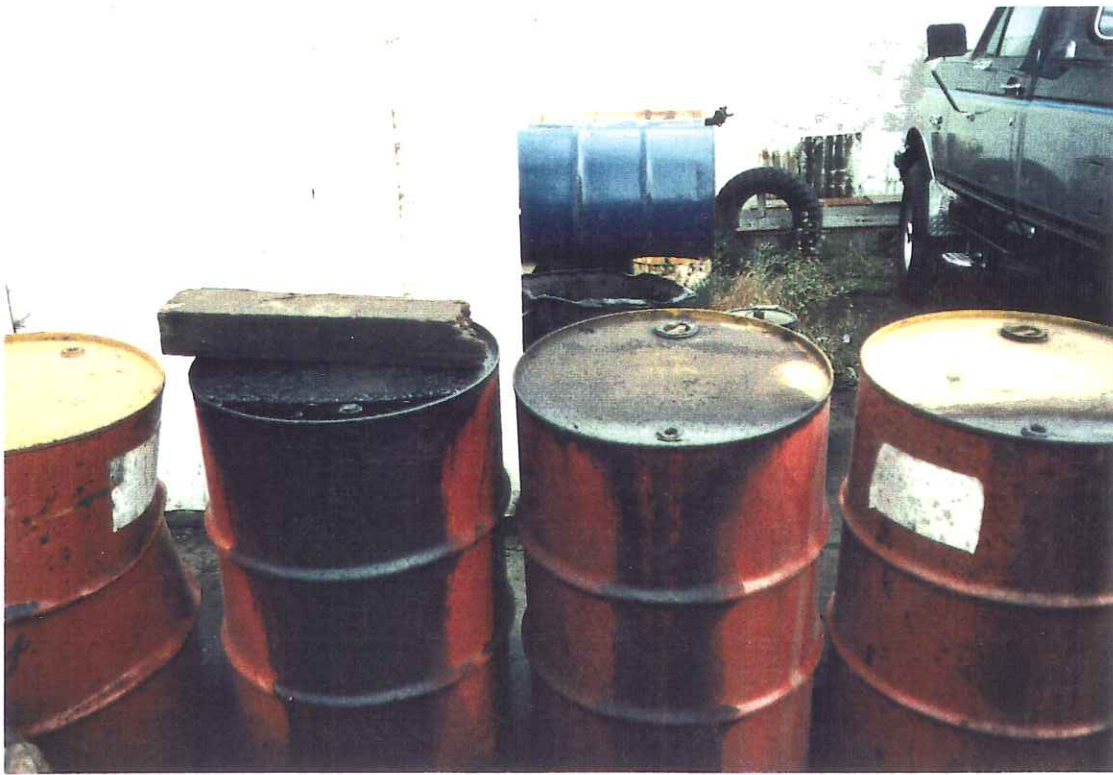
Various materials were observed on-site. These materials included small quantities of anti-freeze, herbicide, water seal, cleanser and latex paints in the restroom storage area; approximately ten 55-gallon drums filled with apparent waste oils and/or diesel fuel, and other miscellaneous solvents, oils, degreasants and motor fuels at the Mt. Adams Loggers Association. Two of the 55-gallon drums in the lumberyard area had leaked some of their contents onto the bare ground, and visible staining was noted.

Leaking 55-gallon Drums in Lumber Yard Area

Significant areas of soil that are visually stained by petroleum products should be evaluated to assess the need for remediation. Visible releases of petroleum products to on site soils may require reporting to the Washington State Department of Ecology under the Model Toxics Control Act (MTCA) July 18, 1990. The MCTA also mandates cleanup of significant releases. We recommend that soil samples be collected and analyzed in order to adequately characterize the existing chemical quality of soil with respect to remedial alternatives. For soils (if any) that exceed state or federal action criteria, on site landfarming or off site disposal may be appropriate.

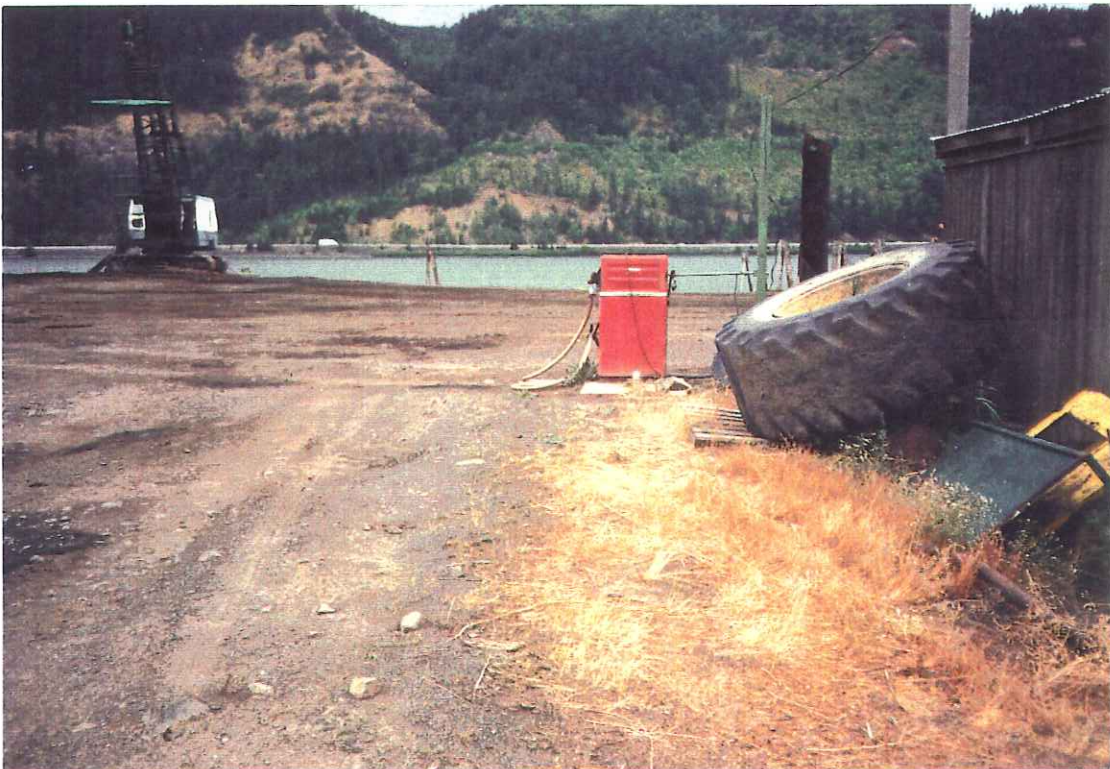
We understand that the underground diesel storage tank was installed in 1980. Under current federal underground storage tank (UST) regulations, nonpressurized tank systems installed after 1979 and before 1989 require leak detection systems by December 1993, and corrosion and spill/overflow protection by December 1998.

If YES, Size 5,000 gal
Contents diesel
Age ≈ 10 yrs.
Leak Detection? unknown
Tested? unknown
Currently Used? yes
Agency Notification? unknown

Pump above Underground Storage Tank in Log Yard

While no action is currently required for the USTs, we recommend that an accurate inventory control program be implemented, and that the UST be leak-tested on a regular basis. The costs to clean up a major long-term release from a leaking tank justify the relatively small cost to periodically test the tank.

Alternatively, in order to minimize long-term future risks, the existing tank system could be replaced with a new installation that meets current design criteria.

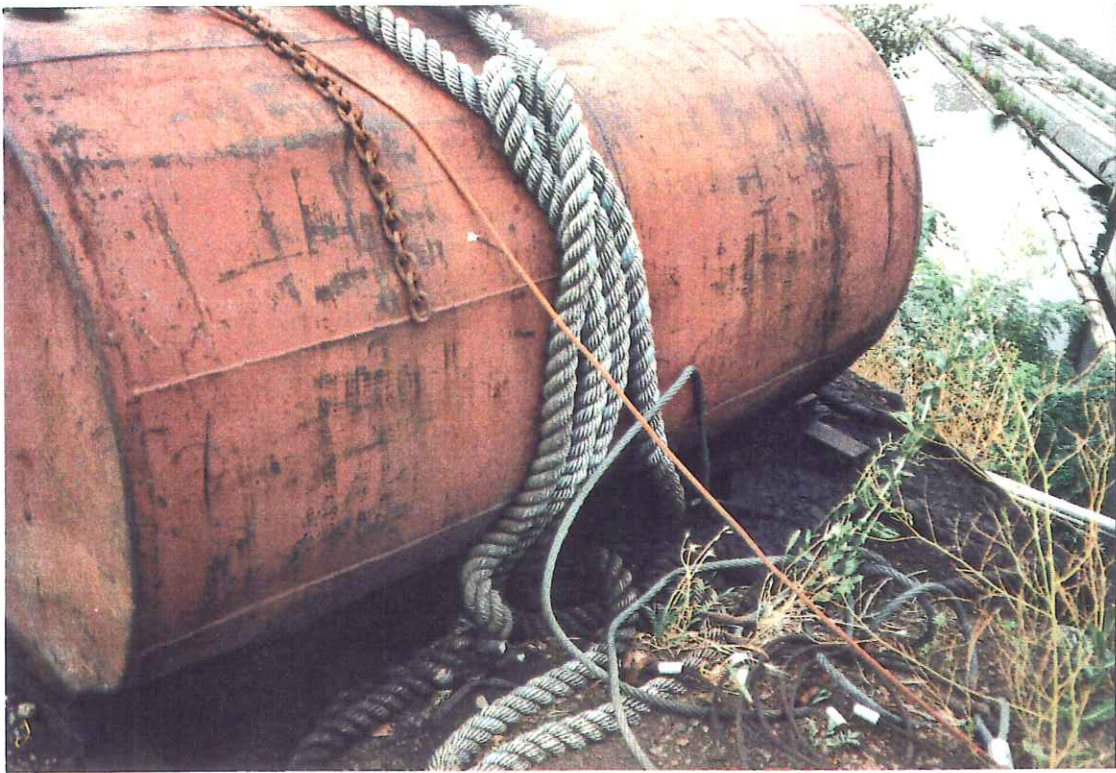
Significant soil staining was noted under one above-ground tank located in the log yard area of the association. The foreman stated that the tank has a capacity of 546 gallons and contains diesel fuel. The diesel is pumped through a hose and valve apparatus from the tank to nearby tug boats.

Above Ground Storage Tank in Log Yard Area

The existing above-ground diesel storage tank should be repaired or replaced to reduce the potential for future releases. Additionally, a containment structure, such as a beamed concrete pad, would assist in controlling spills or other releases from the tank.

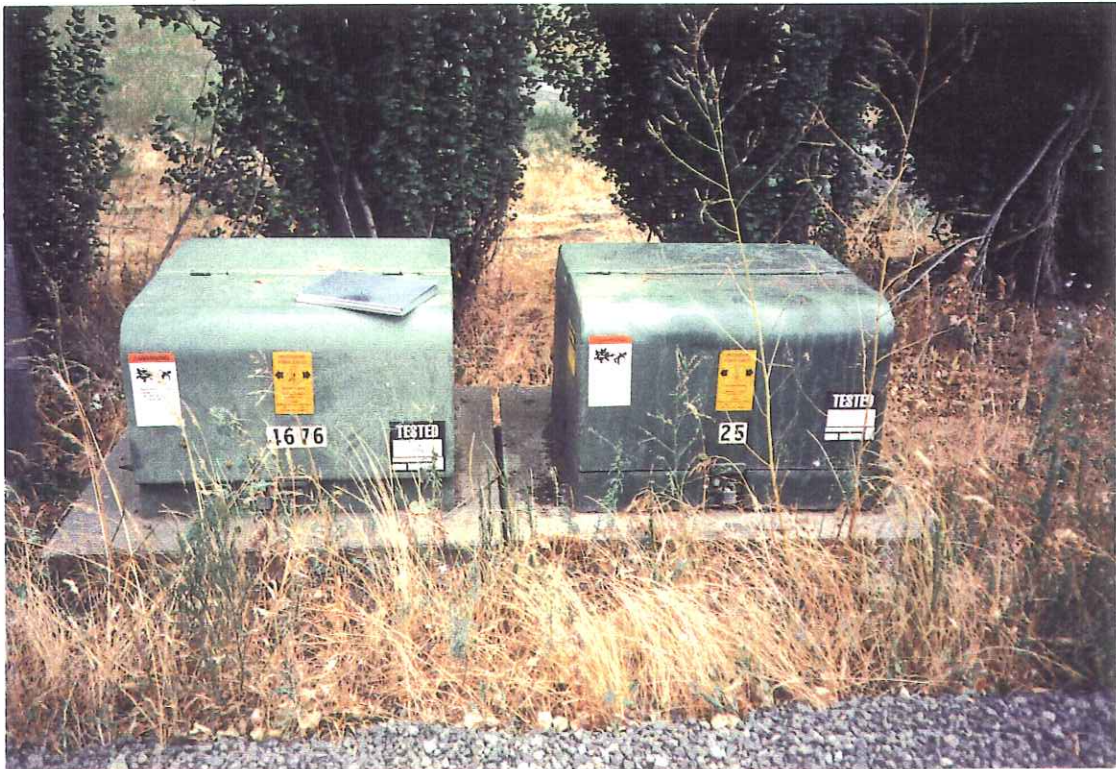
Three pad-mounted and four pole-mounted transformers were found on site. These transformers are owned by the Public Utility District (PUD) #1 of Klickitat County. Al Sanders of PUD #1 stated that all of the transformers have been tested and were found to be non-PCB containing.

Pad-mounted Transformers (#2 and #3)
